Case Study

Retention tanks in Poland

Corrugated steel retention tank solution collects and diverts excess rainwater in Leszno, western Poland

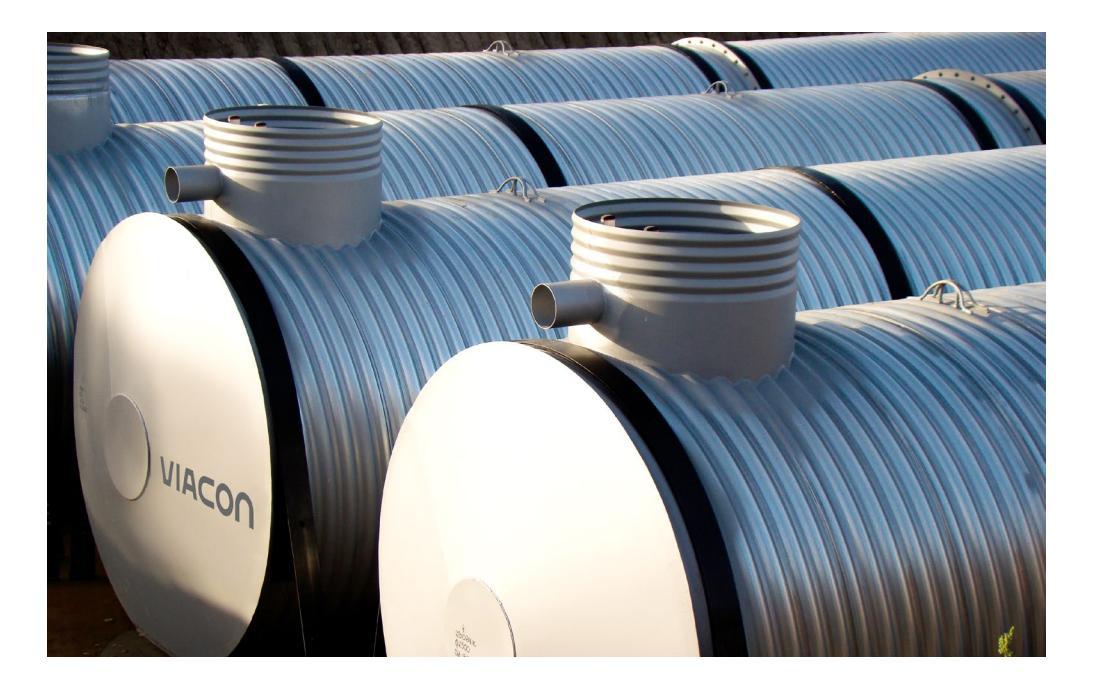
The ViaCon solution was created using four HelCor pipes with a 2,500 mm diameter and a 244.8 m length. The individual pipes were connected to each other using 1,200 mm stubs. The total capacity of the tank is 1,200m3. To protect the tank against vertical movement from the hydrostatic pressure of the groundwater, 72 anchor pieces were attached to the tank.

- Location in car-free green area with no traffic loads
- Corrosion protection: Zinc coating 600g/m2
- Tank inner diameter: 2,500 m
- Tank total capacity: 1,200 m3
- Single pipe length: 62.4 m
- Total length: 244.8 m
- Number of pipes: Four, arranged in parallel, each 61.20 m long
